Petrochemical company uses online information to keep critical machine running

Gulf Petrochemical Industries Company, Bahrain

by **Ron Bosmans**
Principal Engineer
Bently Nevada Corporation

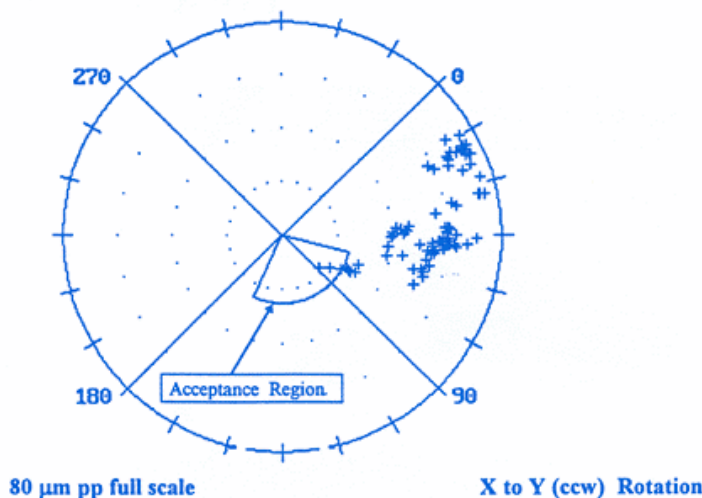
Figure 2
Acceptance Region plot

The TDM2 Software includes an application called an Acceptance Region. The Acceptance Region is used to define a range of "normal" values of 1X and 2X amplitude and phase vectors for each measurement location on a machine. Acceptance Regions are displayed in polar format (Figure 2). The Acceptance Region's limits were established by GPIC personnel, based on machine data collected over a period of four weeks, when the machine was considered to be in good working condition. Significant changes in 1X amplitude or phase that place the vector outside the Acceptance Region indicate aberrant machine behavior.

The TDM2 trend files revealed that the changes in the 1X vectors began to occur during the second two weeks in September 1994. Plant personnel were aware that these changes were occurring over this period and were concerned about continued operation of the machine.▶

Preparations were made to shut down the machine train on January 14, 1995. To safely manage the machine until then, we defined a new Acceptance Region on December 15. If the new Acceptance Region were violated, the machine would be shut down immediately. The rotor's response (Figures 5 and 6) during shutdown indicates that, at the time of the shutdown, the second balance resonance frequency was above running speed. This data confirms the suspected change in system stiffness. Upon removal of the rotor, the seal area was inspected. The substance found on the rotor was identical to that found on the previous rotor. The diametral clearance in the seal had been reduced to 0.01 mm (0.4 mil).

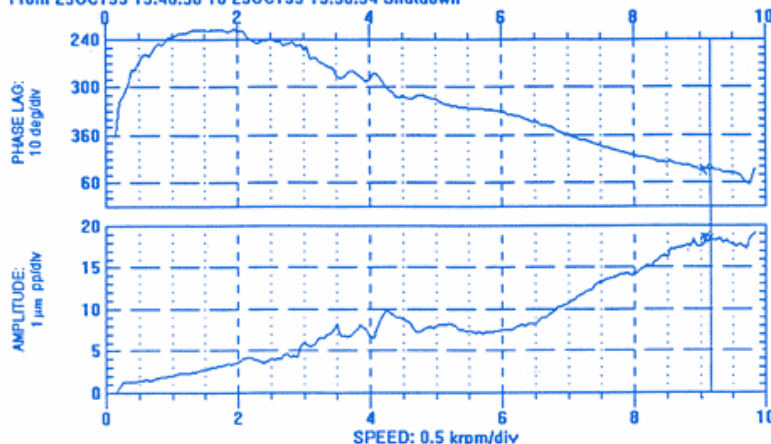
Figure 3
Bode plot of October 1993 shutdown

The Engineer Assist audit, based on vibration data from the TDM2 System, indicated several explanations for this type of behavior. They include changes in the balance state of the rotor and a rotor crack that is propagating. A rotor crack possibility could be confirmed if recent startup or shutdown data were available. However, the only shutdown data available was from a shutdown in October 1993. The data had been acquired with an ADRE® (Advanced Diagnostics for Rotating Equipment) for Windows System; this was old data, but it was still considered useful. The data revealed that the compressor was operating at a speed just above the second balance resonance (critical speed). See Figures 3 and 4. A small increase or decrease in the resonance frequency would explain the observed 1X amplitude and phase change. The equation that governs the frequency of a mechanical resonance is:
